Replacement of steering mid-shaft on my 1997 OBS Ford Powerstroke 4X4 Crew Cab pick up.

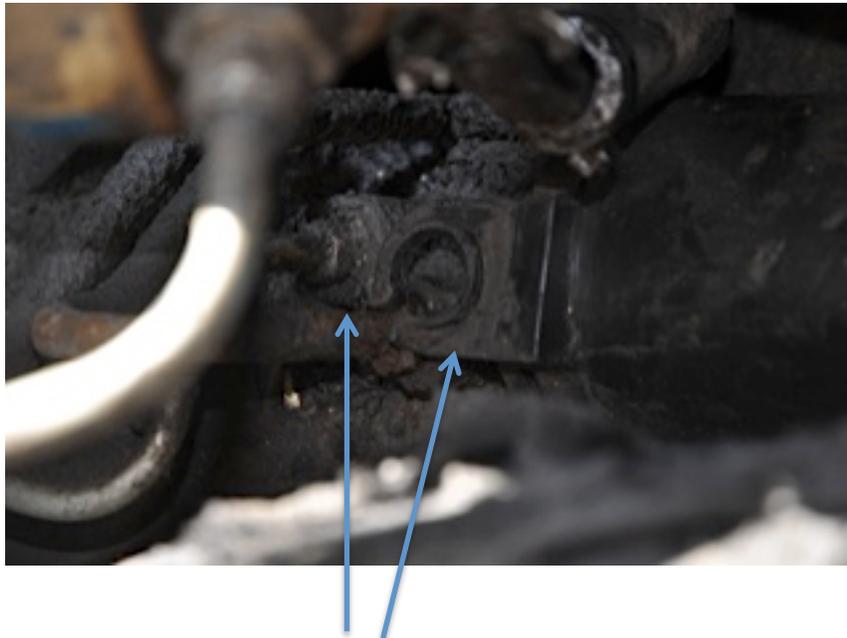
Remove the old mid shaft by sliding the plastic collar up the steering shaft at the steering box end of the shaft. First unclip from the collar as in picture below.

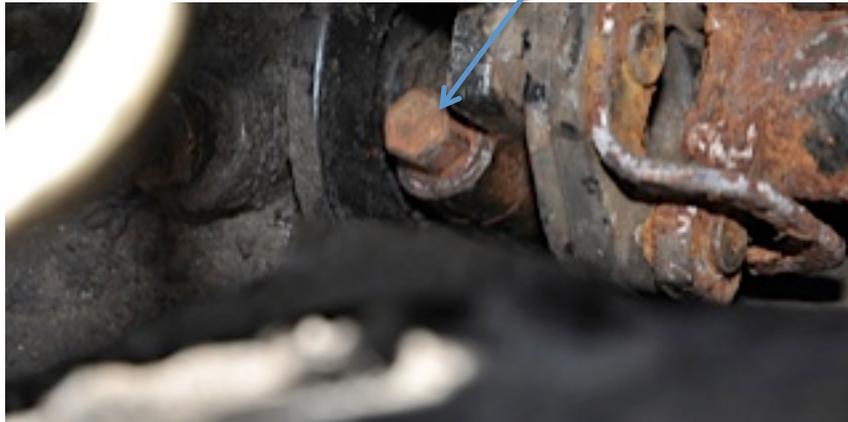
Undo the bolt in photo below that attaches the mid-shaft to the steering box and slide the mid shaft toward the firewall, you will have to collapse

(compress) the mid shaft as far as you can, to make room to pull out of cab.

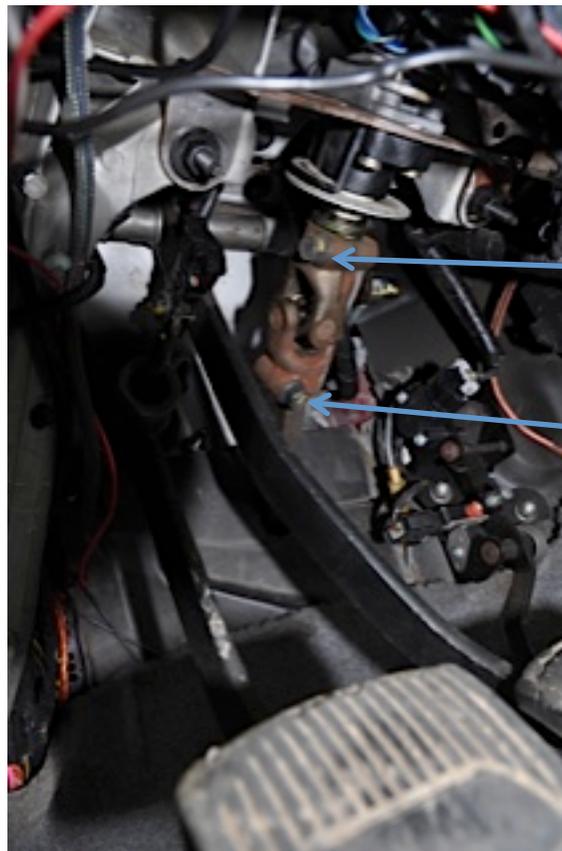
Undo these bolts under the dash on the mid shaft inside the cab above the pedals, so that the steering universal is pulled from both shaft and end of steering column, ensure steering wheel is locked with key out of ignition.

This Bolt

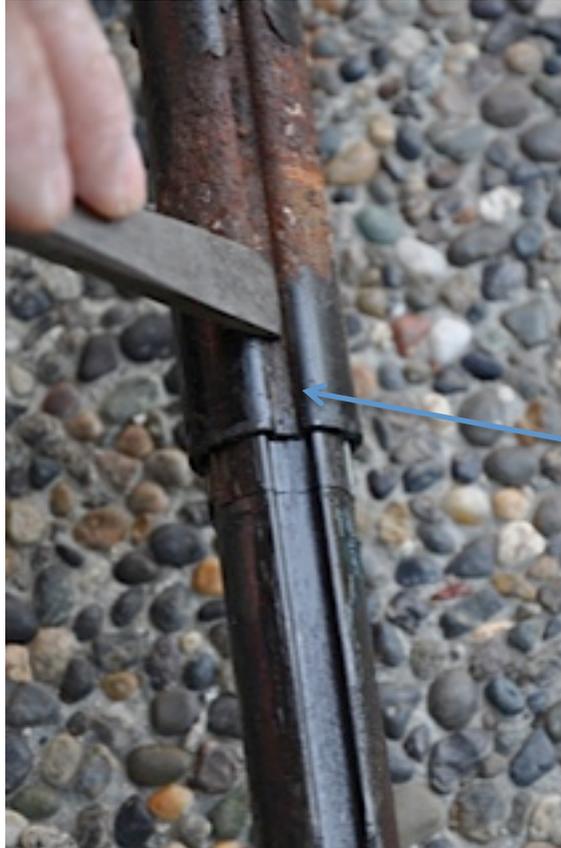
Remove the mid shaft from your truck. As an interim fix you can take the stock shaft and reshape the groove on the shaft with a chisel and hammer, (do this in a vice) re-lube and install this will work for a while but your best bet is to replace with a Borgeson.

The idea is to reshape the outer shaft so it fits snug against the inner shaft

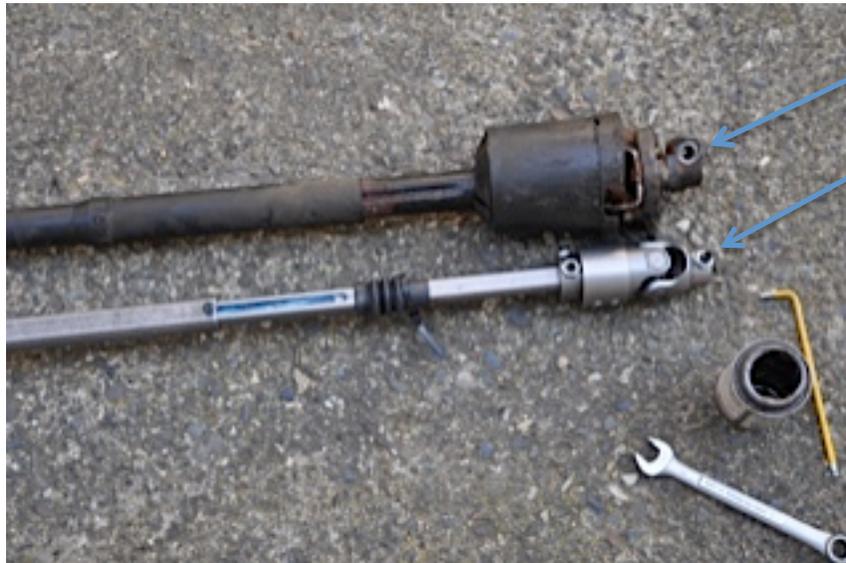
To aid in ease of install I clocked the new Borgeson to match the stock mid shaft configuration. I also cut 1.0 inch off the steering box end of the new shaft to make it easier to install as well.

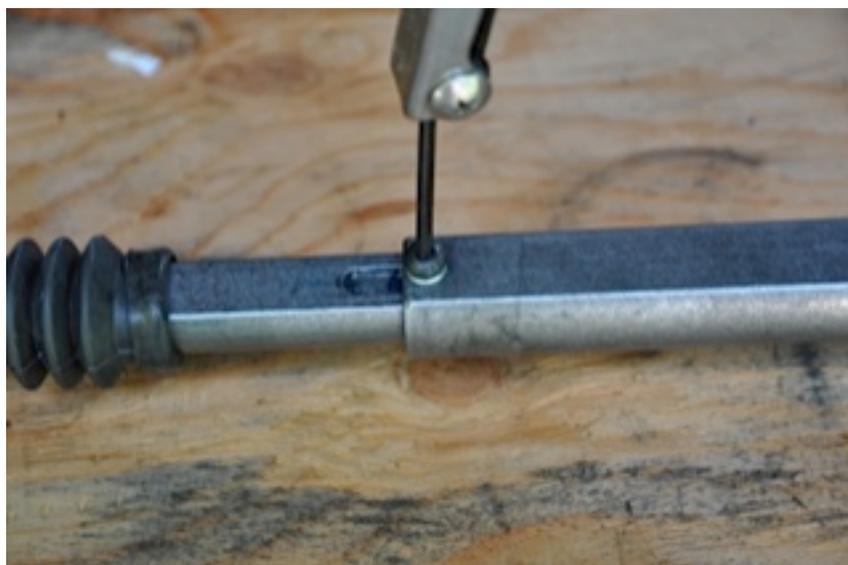
Ensure you undo this allen head so you can collapse the mid shaft as far as possible to aid in the install.

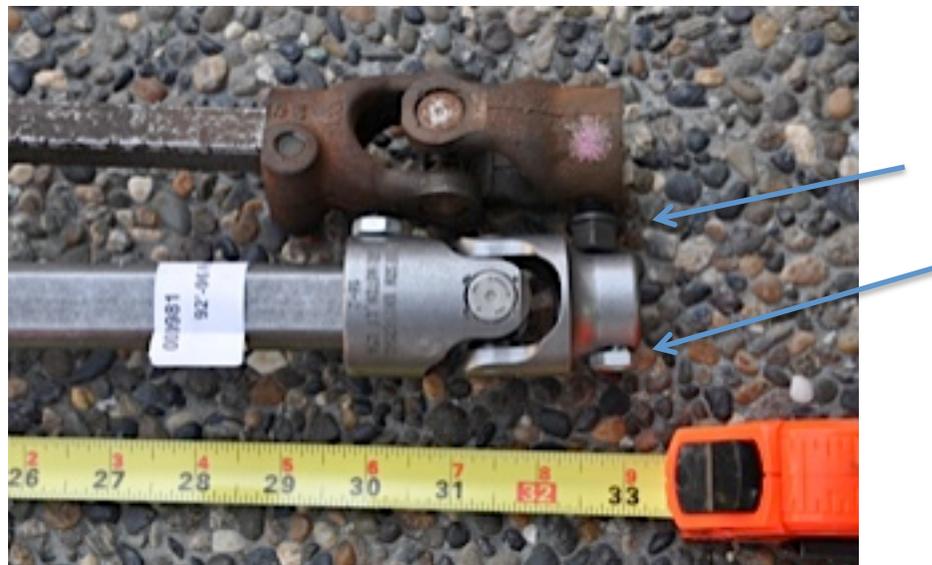
Clocking of steering wheel end of mid shaft, to ease install under dash.

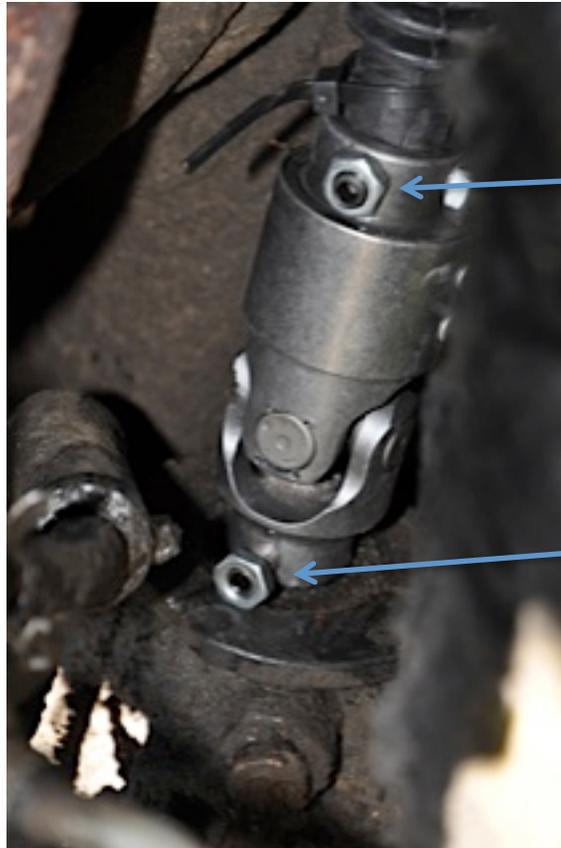
View of steering box end with new shaft installed, ensure you tighten all Allen heads and lock nuts. I did not install the original plastic boot on this end of the mid shaft.
