Technician Turbocharger Guide for the Powerstroke Engine

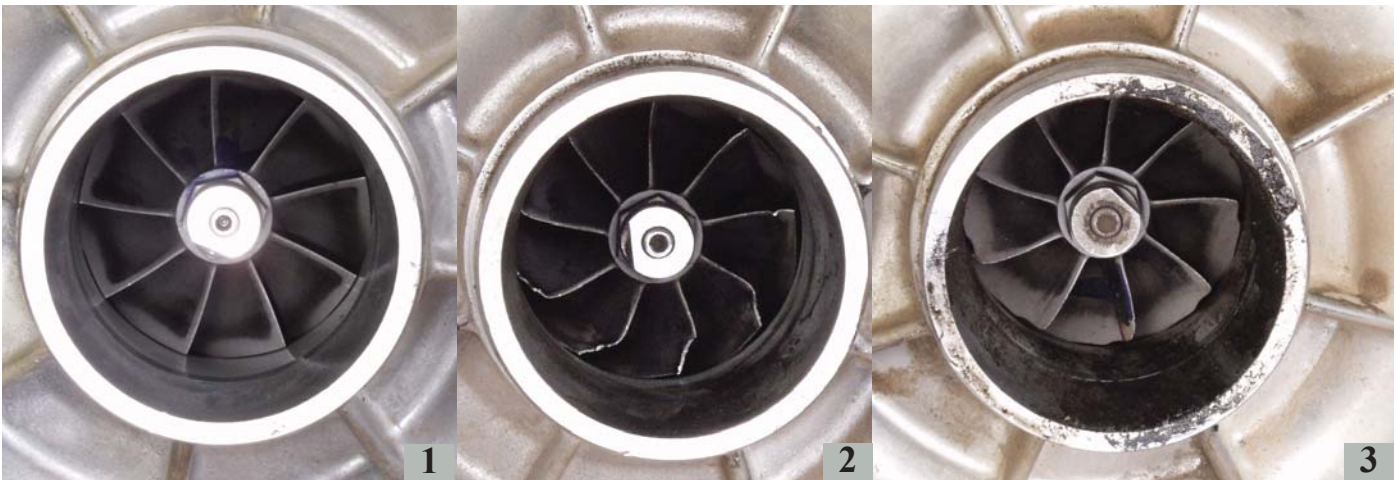
Good Turbocharger:

Compressor blades are clean and straight. There are no large gaps between the compressor housing and the compressor wheel. No visible damage to blades. This turbocharger should not be replaced.

Foreign Object Damage:

This compressor wheel shows signs of some outside object (nuts, bolts, screws, etc.) coming in contact with the blades while they were spinning.

Dirt Ingestion:

Also called dusting. The compressor wheel blades show signs of erosion from dirt entering the intake air system. The blades are rounded off and there is dirt accumulation in the compressor inlet.

Note: If damage to the compressor wheel is found, the intake air system should be cleaned and inspected for foreign objects, poor maintenance, broken components, or improper installation.

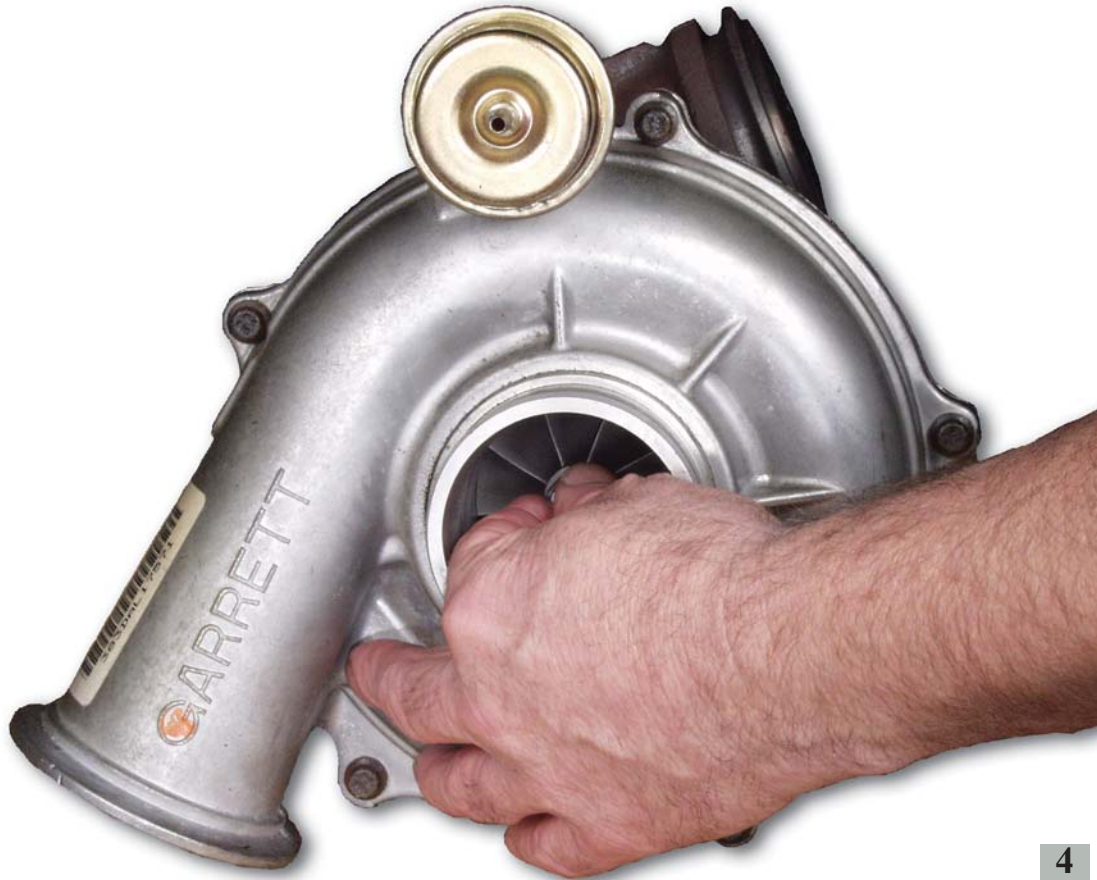
4

Does any evidence of wheel to housing contact exist, such as witness marks on the housing or rolled edges on the wheel? Before testing a service part replacement, pour some clean oil into the lube oil passages.

Spin the compressor wheel to make sure that it spins freely. The wheel should not contact the housing.

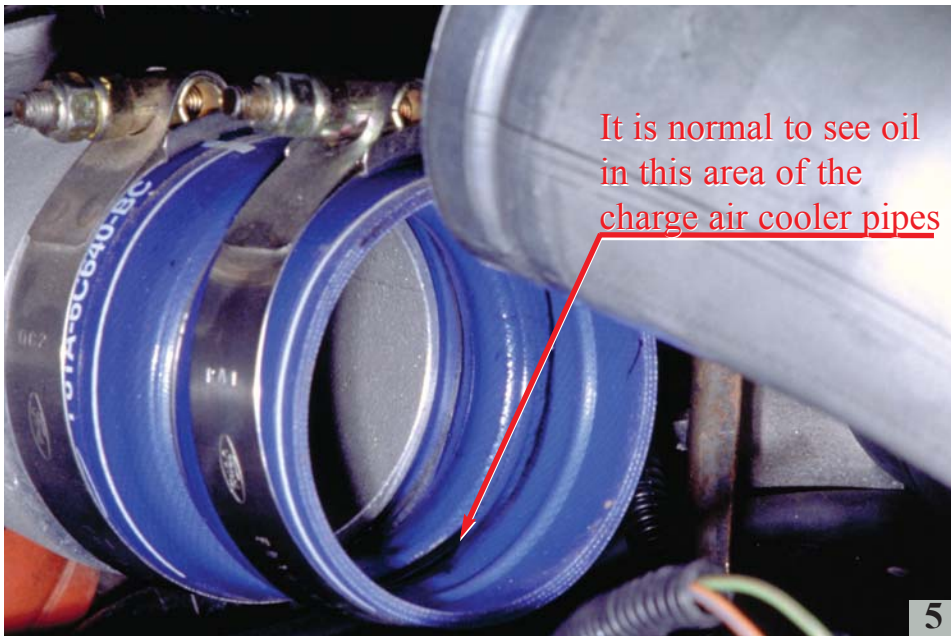
Normal Oil Carryover: The photo to the left shows normal oil carryover in the charge air cooler pipes. This condition can be aggravated by excessive air inlet restriction. The turbocharger should not be replaced for this condition.

Normal Oil Seepage: The photo to the right shows normal oil seepage on the charge air cooler connections. This condition can be aggravated by excessive air inlet restriction or an overfilled crankcase oil level (refer to SSM 11982). The turbocharger should not be replaced for this condition.

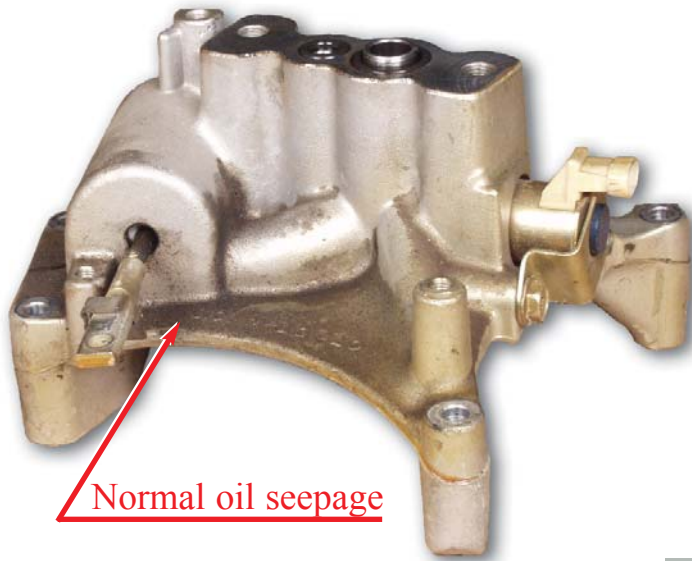
Normal Oil Seepage: It is normal to see some oil seepage past the seal on the EBP actuator rod. The photo to the left shows this normal seepage.

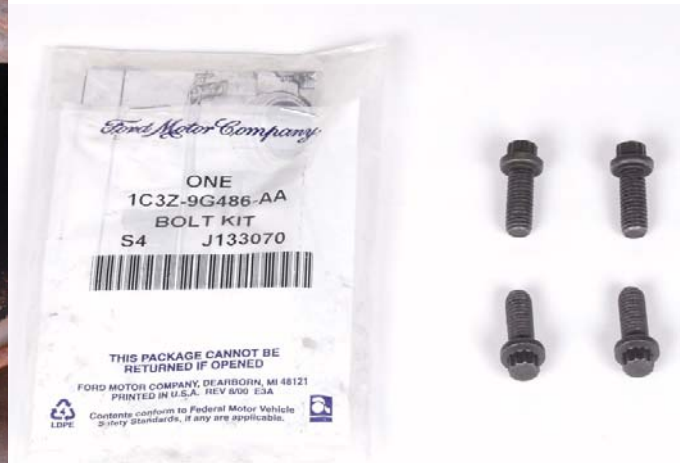
Some turbochargers have experienced turbine housing mounting bolt back out. This does not require turbocharger replacement unless the turbine wheel has contacted the housing and been damaged. Replacement bolts with an interference thread for improved retention are available for service. TSB 03-14-09 advises that the part number for the bolt kit is 1C3Z-9G486-AA. Do not try to "chase" the threads on these bolts.

When loose or missing bolts are found, replace the bolts with part number 1C3Z-9G486-AA per TSB 03-14-09.

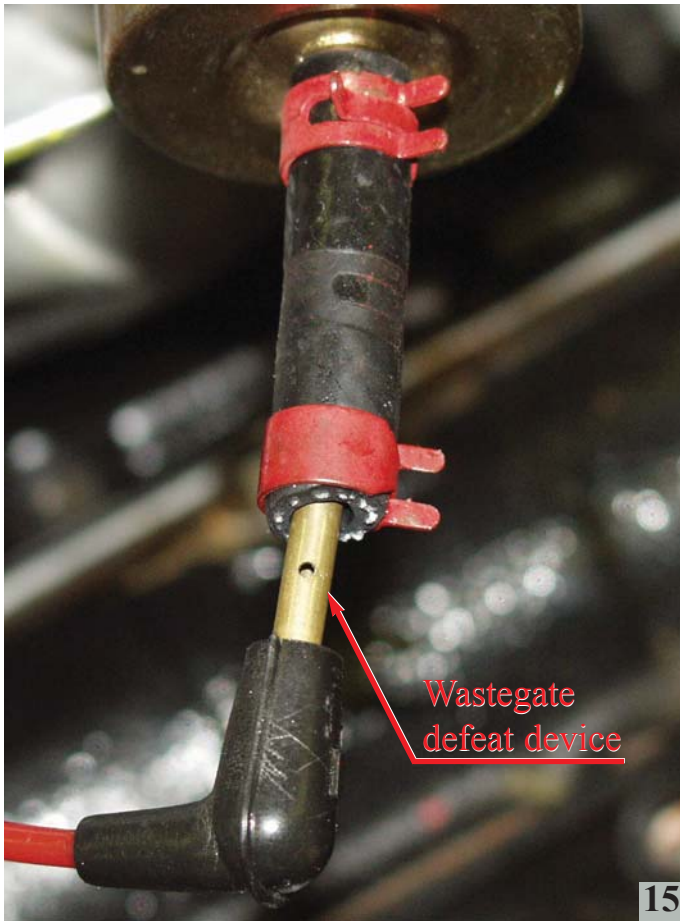
15

Aftermarket Performance Enhancers: Above left is a wastegate actuator defeat device which will not allow the wastegate to operate correctly.

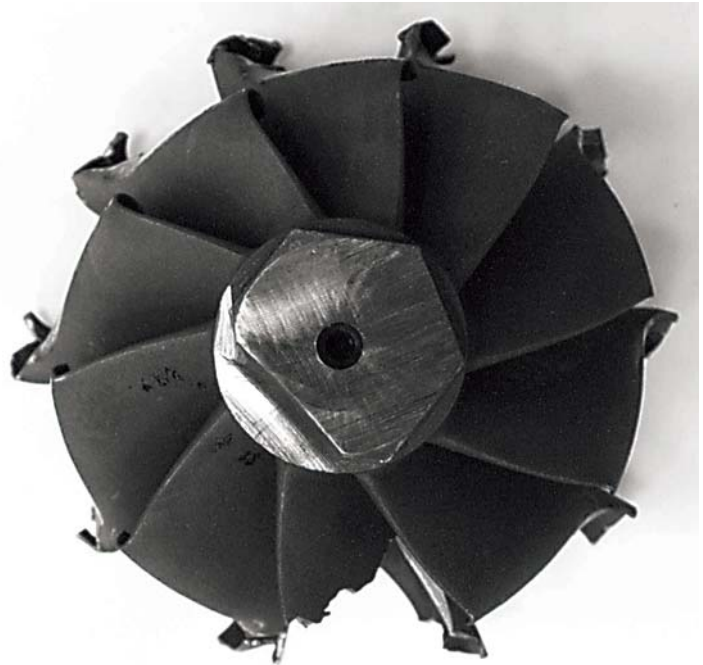
16

Structural Failure: Above right is a turbine wheel that has failed due to overspeed as a result of performance modifications.
