Technician Turbocharger Guide for the Powerstroke Engine

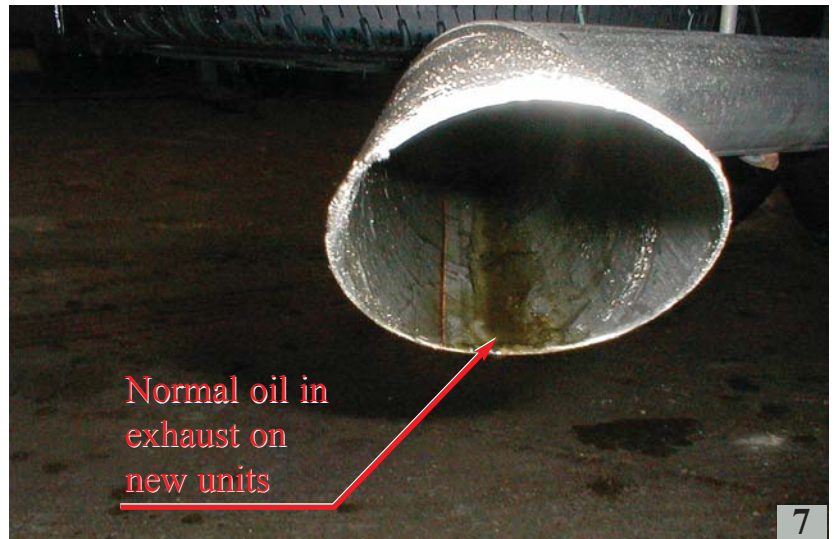
On very low mileage trucks, (typically less than 1000 miles) some turbochargers have been replaced because of an "oily residue" exiting the exhaust pipe. Be aware that during the manufacture of exhaust pipes, lubricants are used in the bending process and to prevent rust. Do not consider replacing the turbocharger just because oil is coming out of the tailpipe. The initial oil in the engine has had dye added, so inspect with a blacklight first. If it is thought that the oil is from the engine, loosen the exhaust pipe from the turbocharger outlet and look for signs of engine oil exiting the turbocharger. If the turbocharger is leaking oil into the exhaust, expect to find the bearings in the unit to be worn and for wheel rub to be present.

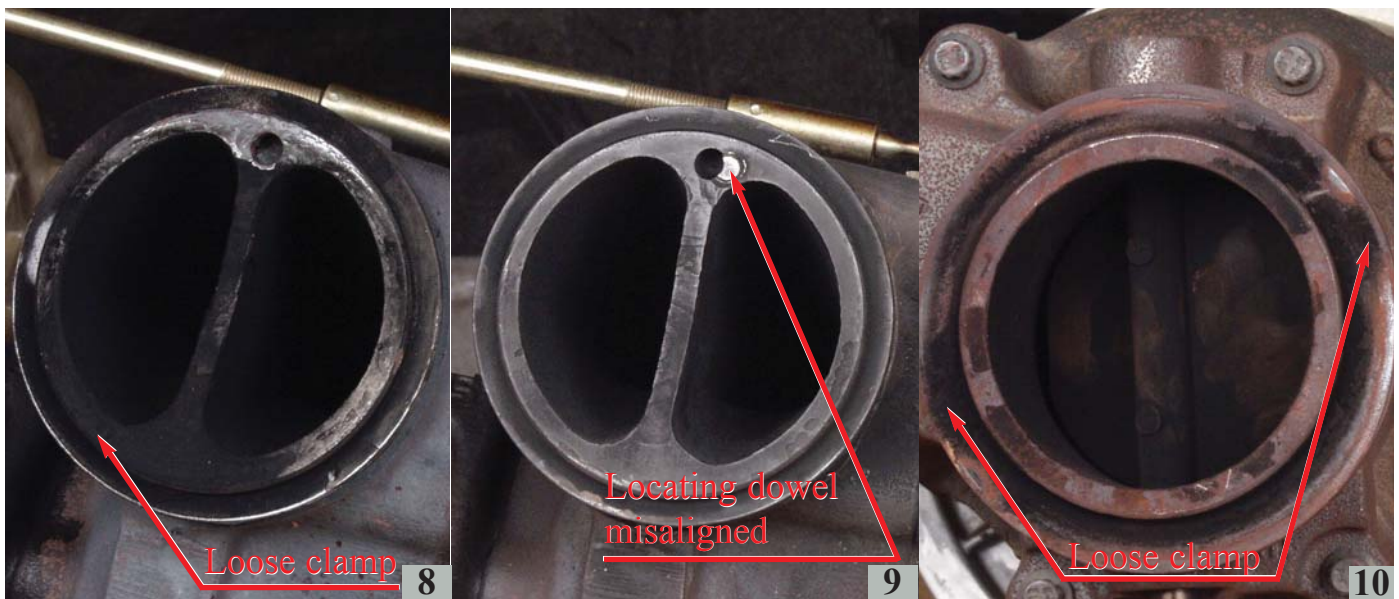
Turbochargers have been replaced for noise concerns when the concern is exhaust mis-alignment at the connections. Carefully inspect the exhaust connection at the inlet to the turbine housing, and the turbine exhaust outlet to exhaust pipe connection. Mis-alignment at these connections will often produce noise complaints. Re-aligning and tightening the V-band clamp can often repair the noise concern. If the turbocharger itself is responsible for excessive noise, expect to find wheel to housing rub, and bearing failure, as illustrated in photo 4.

NOTE: The exhaust backpressure device during its normal function will change the sound of the engine, in cold ambient conditions. Some vehicle operators may not understand the function of the device. Refer to cold weather operation in the Owner's Guide Supplement to the Owner's Manual. Refer to SSM 16697.

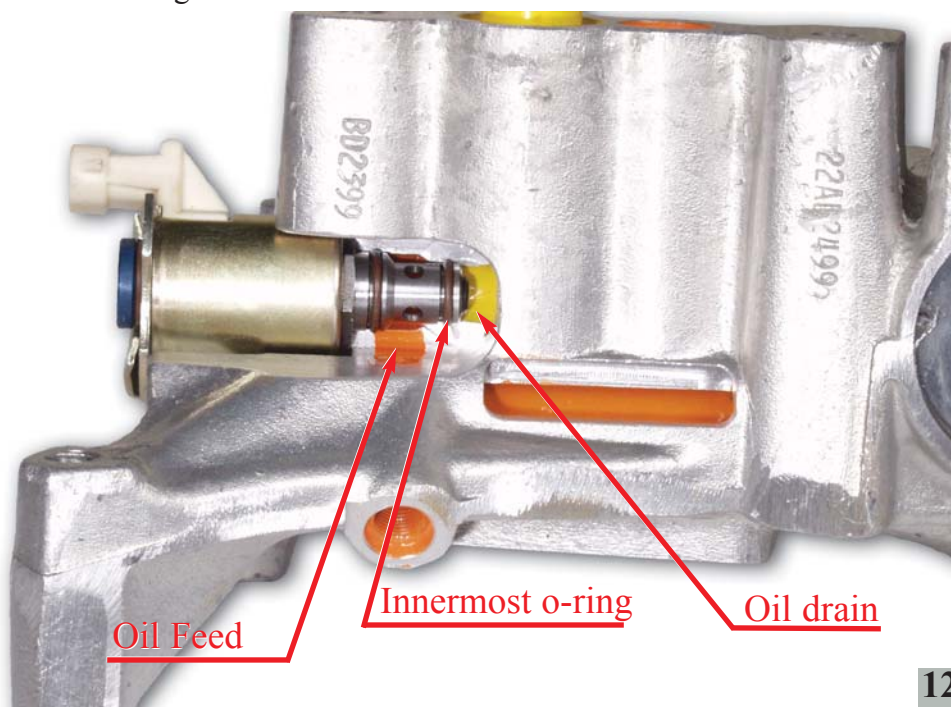
Turbochargers have been replaced when the exhaust backpressure system (EBP) malfunctions. If performance is low, disconnect the EBP actuator rod from the bell crank, and tie the valve open. If this resolves the performance concern, make sure the valve in the exhaust rotates freely. If it does, then suspect the regulator to be at fault. The exhaust backpressure regulator and the regulator o-rings can be serviced separately from the turbocharger.
